ICE HOUSE, CARLTON TOWERS, CARLTON,
GOOLE, NORTH YORKSHIRE

ARCHAEOLOGICAL EXCAVATION,
INVESTIGATION AND RECORDING

Report no: 2017/533.R01
Version: Final
Date: May 2017
Author: Shaun Richardson & Ed Dennison

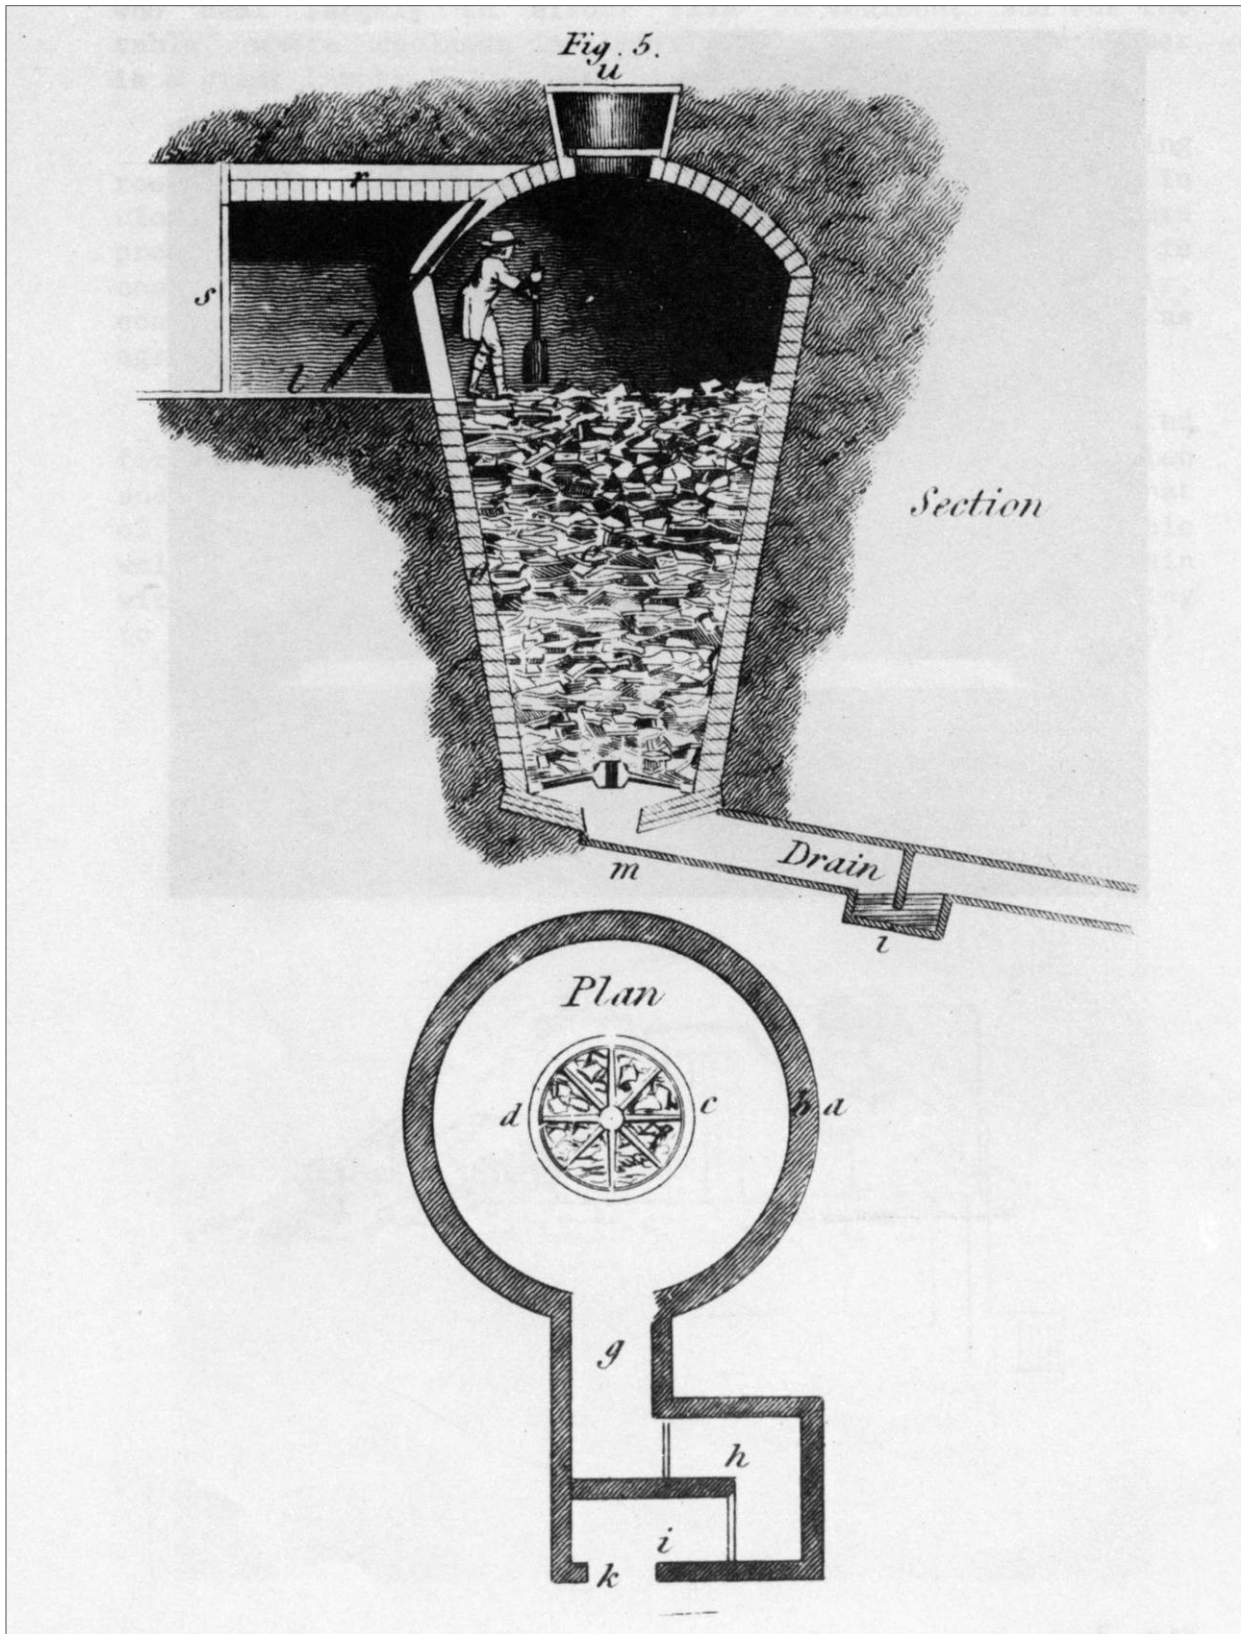
PROJECT		ICE HOUSE, CARLTON TOWERS	
TITLE		TYPICAL EARLY 19TH CENTURY 'CUP AND DOME' ICE HOUSE	
SCALE	NTS	DATE	MAY 2017
EDAS		FIGURE	3

Taken from Rees 1819 Cyclopaedia or Universal Dictionary of Arts, Science & Literature (reproduced in Ellis, M 1982 *Ice and Icehouses through the Ages*, figure 4).

- 4.4 The commonest type of ice house built during this period was what is described as the 'cup and dome' form, often constructed in brick, with a dome or vault covering the ice well or chamber, with sides sloping downwards and inwards to a sump or drain at the base (see figure 3). The extent to which the ice well was sunk into the sub-soil was dependent upon the nature of the ground; in heavy clay or strong loams, it was raised as far above the ground surface and water table as possible so as to facilitate drainage, but in sandy soils, chalk or gravel, the ice well could be sunk to a substantial depth. The dome above was often covered with an earth mound, and was approached by a vaulted passage, again sometimes covered with earth (Beamon & Roof 1990, 56-59 & 86).

- 4.5 The 'cup and dome' form had several advantages. It was structurally enormously strong and very effective in withstanding the underground stresses. The sloping sides encouraged the drainage of melt water into the sump. Ease of loading was also an important consideration, and the doors of these type of ice houses were built just below or into the springing line of the dome, so at least two thirds of the volume of the ice well was below the waist level of people standing in the passage. In this way, ice could be tipped down into the well from passage level, making it easier to fill than if ice had to be manually stacked or piled up. Straw was most commonly used as an insulating material, sometimes tied into bundles and placed between the side walls of the well and ice as it was being loaded; some wells were provided with a timber lining, held in place by iron pegs. Others had a covered manhole structure in the roof of the dome or vault which could be used for loading. When the ice house was full, the ice was covered with straw or reeds before the external door was shut. Due to the sloping sides of the well, any melting ice slid down the sides, compacting and consolidating under the weight of the ice above, so maintaining a minimum surface area and facilitating its continual freezing. However, the main disadvantage of this form of structure remained the expense of construction (Dennison 1989; Beamon & Roof 1990, 59, 61-62 & 110-112).

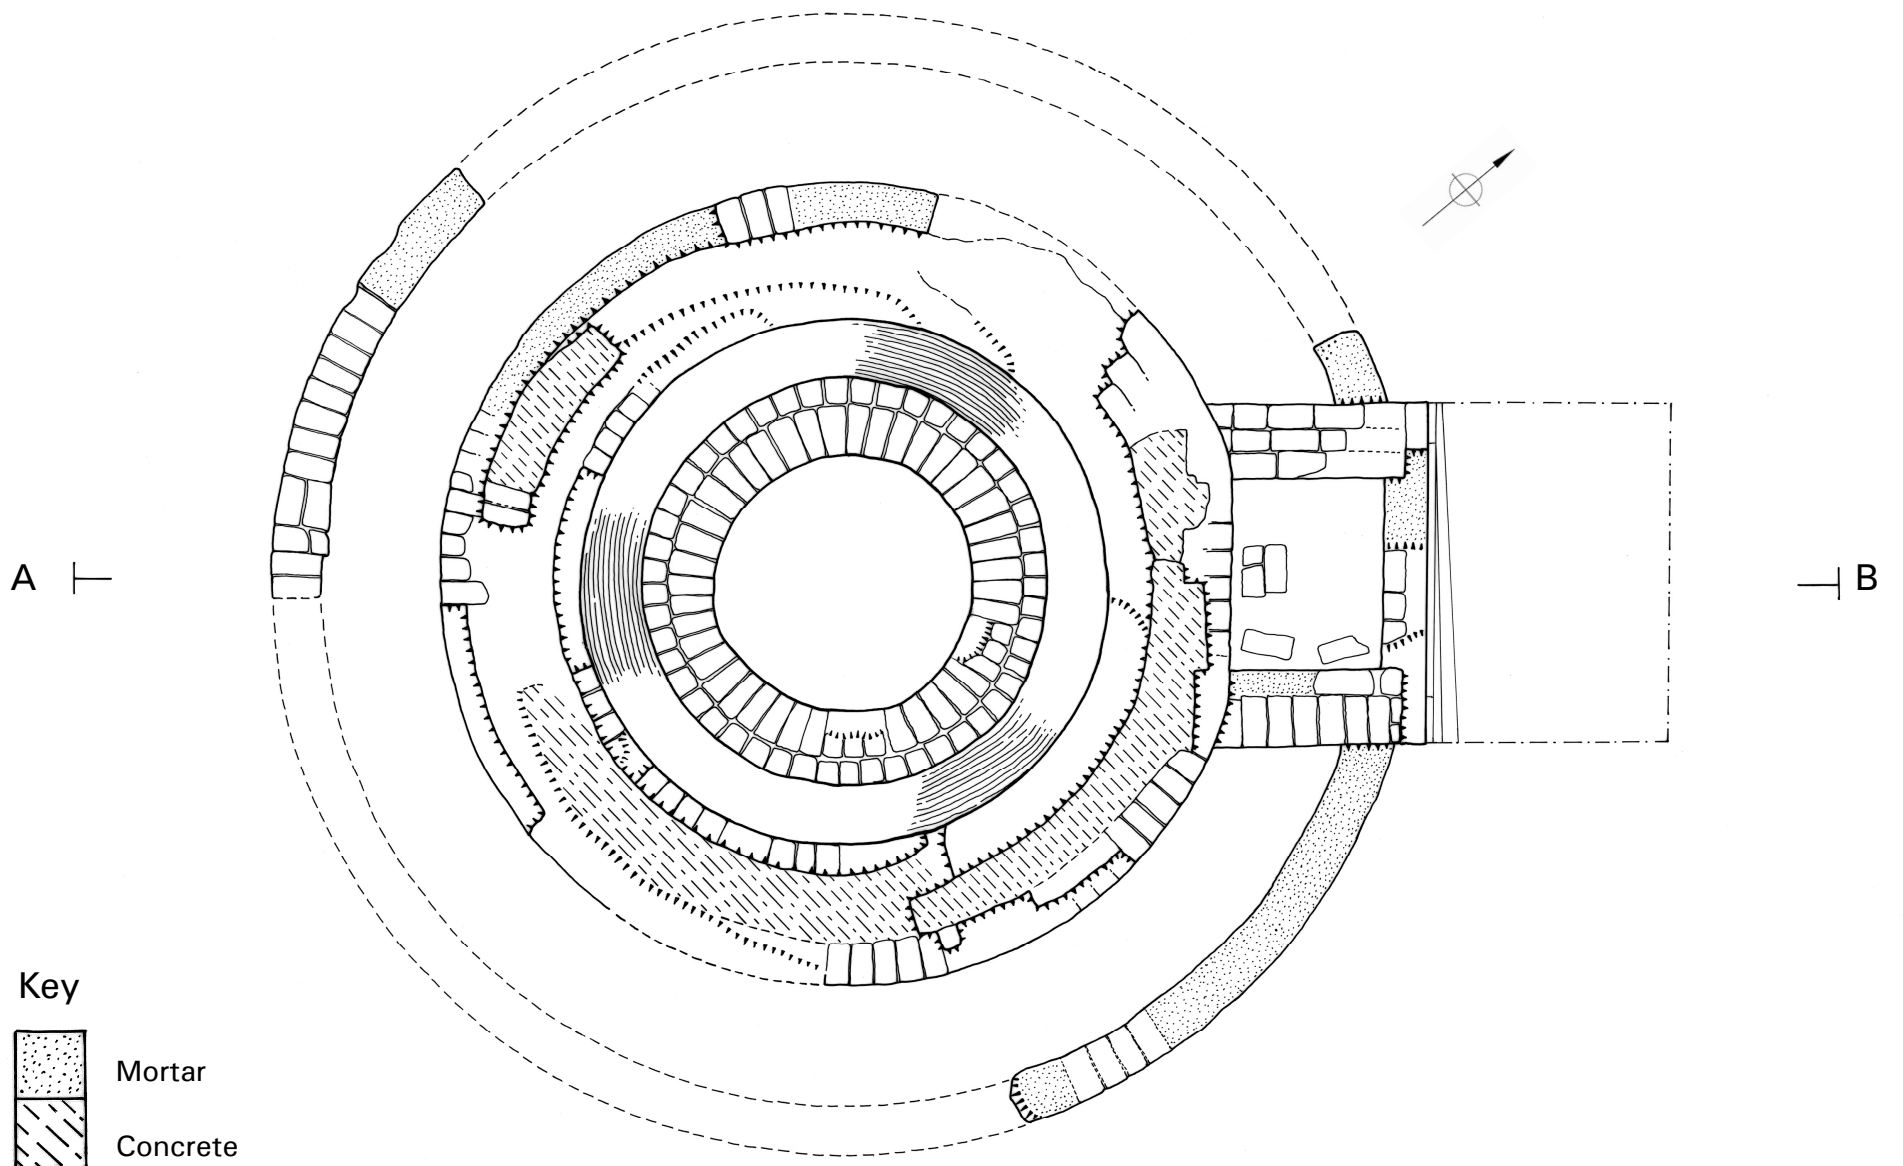
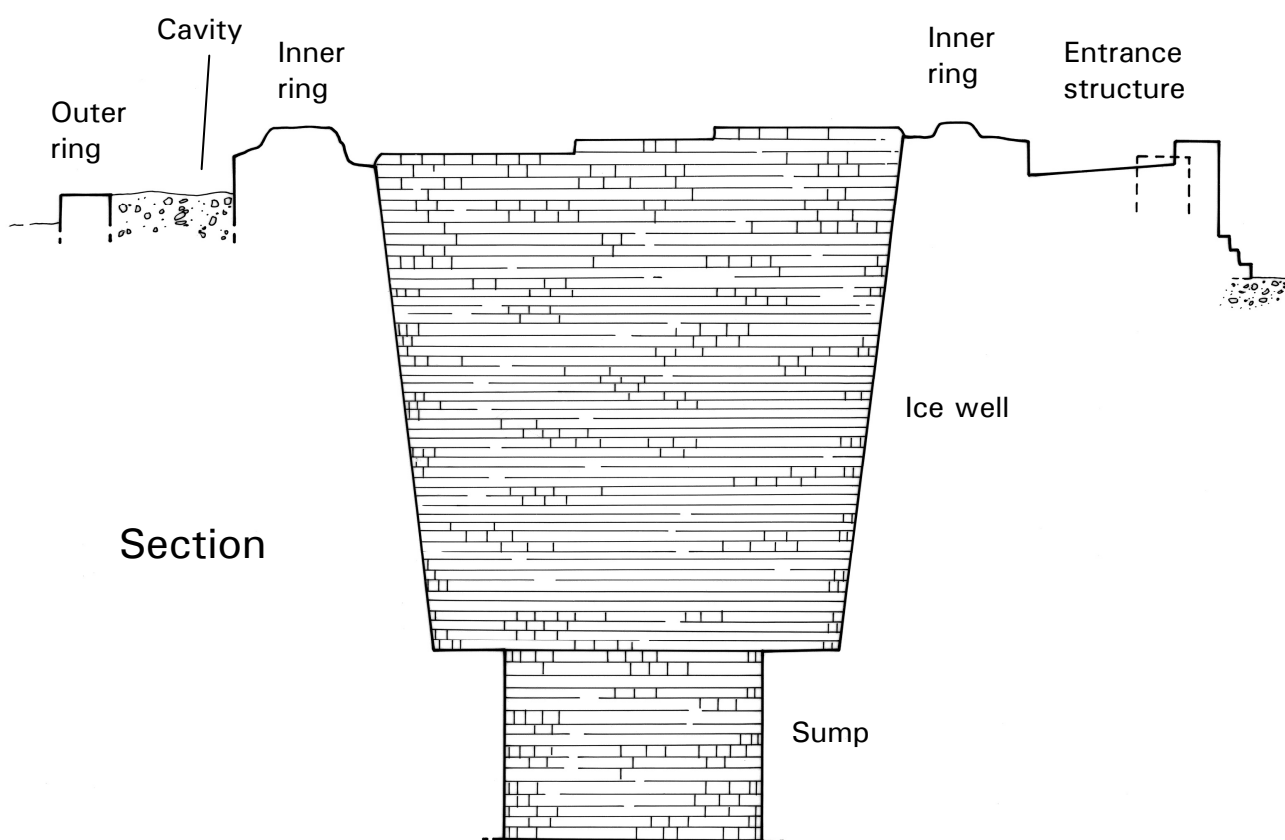
PROJECT		ICE HOUSE, CARLTON TOWERS	
TITLE		GROUND PLAN AND SECTION	
SCALE	AS SHOWN	DATE	MAY 2017
EDAS		FIGURE	5

Ground Plan

Section

- 5.1 A description of the ice house is given below, beginning with the location and plan form, the structure and materials, then proceeding to the interior. The description refers to the plan and section (see figure 5).

- 5.2 As has been already noted above, the ice house is located some 120m west of Carlton Towers itself, within a belt of woodland largely comprising self-seeded sycamores, set between the house and the rear plots of the houses fronting onto the A1041 High Street through Carlton. Following clearance of vegetation, the structure of the ice house was seen to comprise two concentric circles or rings of brickwork, the inner ring forming the ice well; the average gap or cavity between the two rings is 0.62m (see plate 1). The ice house was once of the common ‘cup and dome’ form described above, although the upper part of the structure above-ground has been largely demolished. Most parts of the structure were built from brownish-red handmade bricks (average dimensions 260mm by 130mm by 60mm), set with a very pale brown lime mortar and laid in an irregular bonding pattern, with large numbers of headers interspersed with stretchers to each course. The sump at the base of the ice well is built from unmortared bricks, laid almost entirely as headers, in order to aid drainage. Many of the bricks are tapered to make the circular form of the sump easier to construct; they have average dimensions of 255mm by 120mm to 85mm by 50mm.

- 5.3 The outer ring of brickwork has an external diameter of 6.00m and is itself 0.24m wide (the length of a single brick); it survives to a depth of at least 0.30m. The inner ring, forming the well, has an external diameter of 4.30m and is itself 0.75m wide; the upper part has been rather crudely repaired in the past using a concrete capping, presumably to prevent the truncated remains from weathering and decaying further. To the southern side, the outer face of the well preserves sections of a smooth sandy render (see plate 2). The outer ring is broken to the north-east side by the former entrance to the ice house, formed by a brick structure measuring 1.15m in length by 1.80m in width (see plate 3). The entrance would once have had a doorway to the north-east side, and have been covered by a vaulted passage leading to the ice well. The entrance passage is shorter than might be expected; Buxbaum (2014, 16-17) suggests that the vaulted passage was typically ten feet (c.3.30m) long. Excavation of a small test pit to one side of the

- 5.4 The outer face of the ice well is slightly flattened where it meets the entrance. Although the walls of the well are 0.75m wide, no clear traces of an internal cavity were uncovered during the excavation. The internal sides of the well slope very steeply downwards to meet the base of the interior; the internal diameter decreases from 2.80m to 2.15m over a vertical height of 2.80m (see plates 4 and 5). At 2.80m below the surviving top of the inner ring, the sides of the well step inwards by 0.40m to form the sump of the ice house. This sump has an internal diameter of 1.36m, and a total depth of 1.00m (see plate 6). At its base, the sump gives way to a clean sand (see below). The sump would once have been covered by a timber grating or perforated iron plate, and might once have been filled with stones or clinker to aid drainage, although no such material was recovered during the excavation. The form of the sump at Carlton Towers is typical for what would be expected of a later 18th century 'cup and dome' ice house placed in a lighter sandy soil (Beamon & Roaf 1990 100 & 103; OAU 1995, 9-10). The dry orange sand (005) exposed at the base of the sump is likely to be an artificial deposit laid down to enhance the drainage of the ice well.

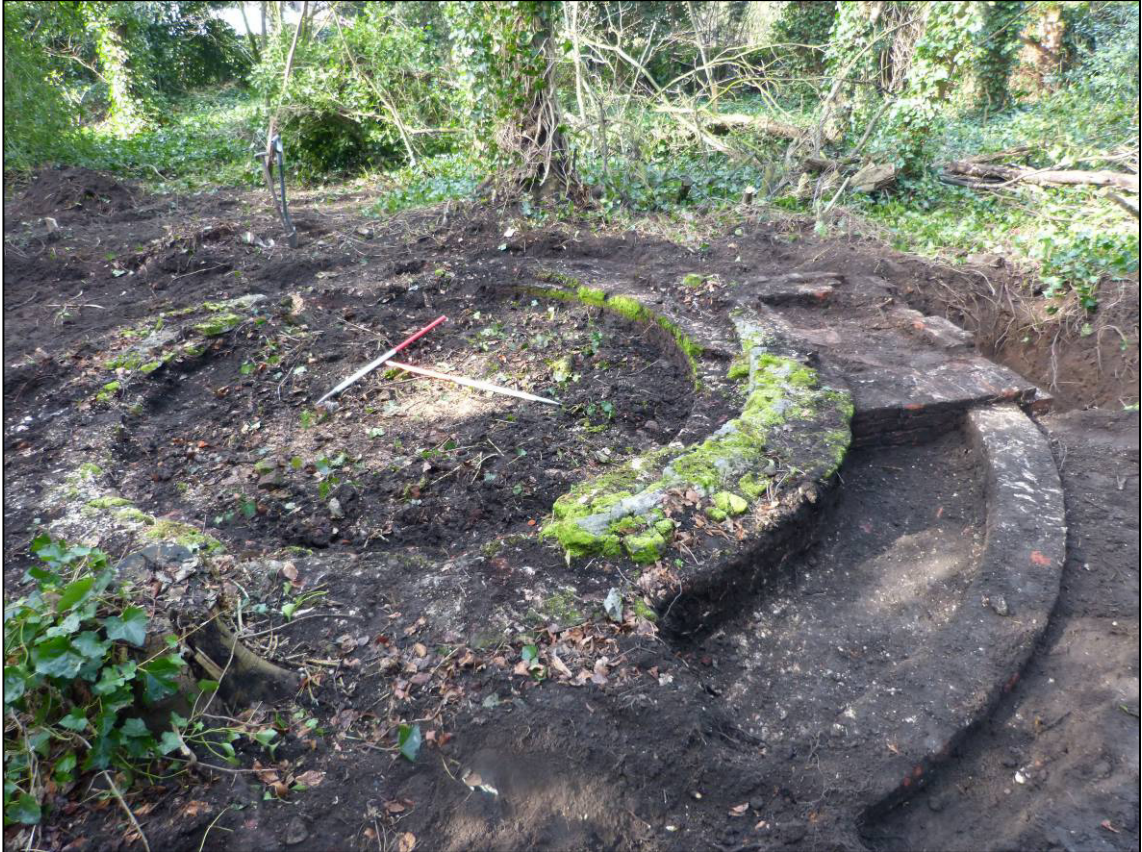
Plate 1: Ice house after initial clearance, looking N (2 x 1m scale) (photo 1/167).

- 5.5 As noted above, the majority of the interior of the ice house was excavated by hand over a period of two days. At the commencement of the excavation, only the uppermost courses of a small part of the ice house remained visible. Careful clearance to reveal the extent of the surface remains involved the removal of a mid-brown sandy silt (001), containing frequent inclusions of rounded pebbles (up to 0.10m across) and infrequent handmade red brick rubble. A number of *ex situ* finds were recovered during the clearance works (see below).

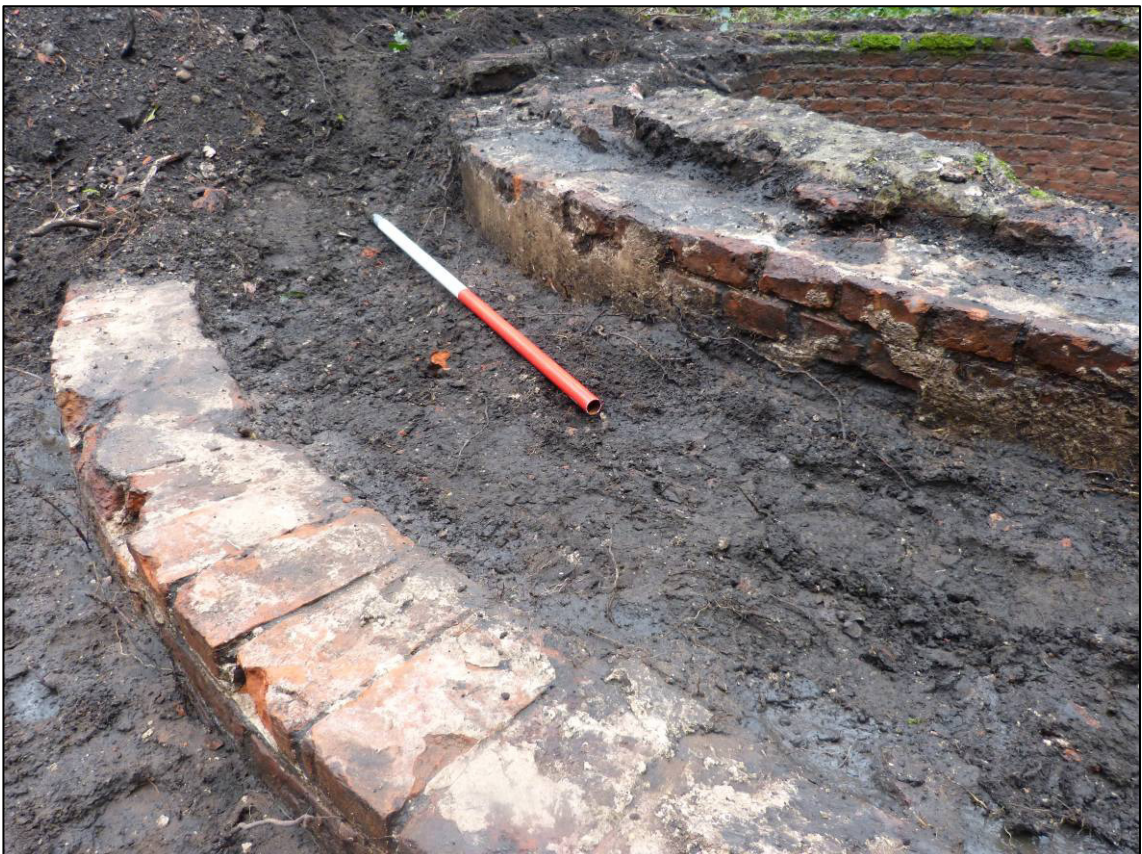
Plate 2: Outer ring of brickwork and render to external face of ice well, looking N (1m scale) (photo 2/216).

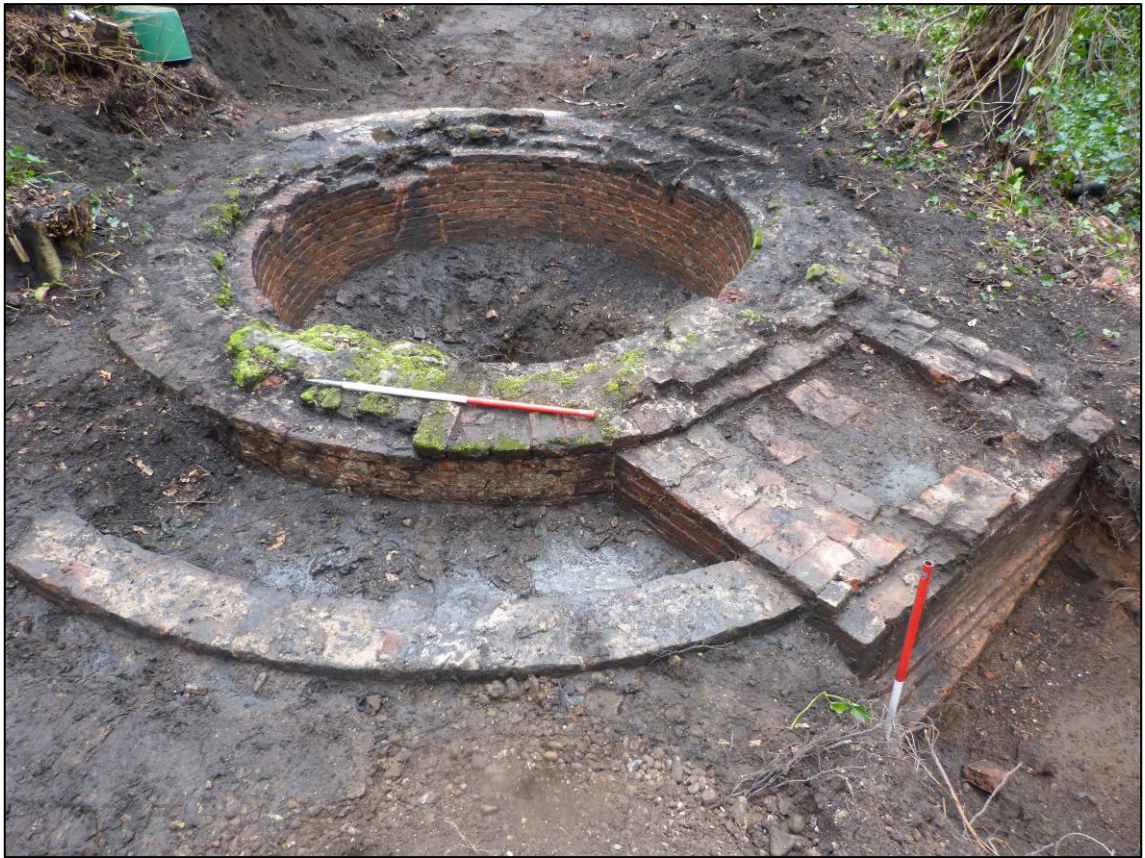
Plate 3: Partly excavated ice house, showing entrance, looking NW (2 x 1m scale) (photo 2/220).

entrance revealed the structure to extend to 0.70m below ground level, with stepped footings, although there was no indication that it had ever extended further to the north-east in plan. Several worn bricks to the upper part of the structure may form the remains of a floor surface. In addition, there were several moulded stones in the vicinity of the ice house that might once have formed part of an external door surround; in the later 18th century, neo-classical facades were sometimes given to ice houses on large country estates, whereas through the early to mid 19th century, Egyptianate, Chinese or rustic styles became popular (Beamon & Roaf 1990, 27 & 29-30).

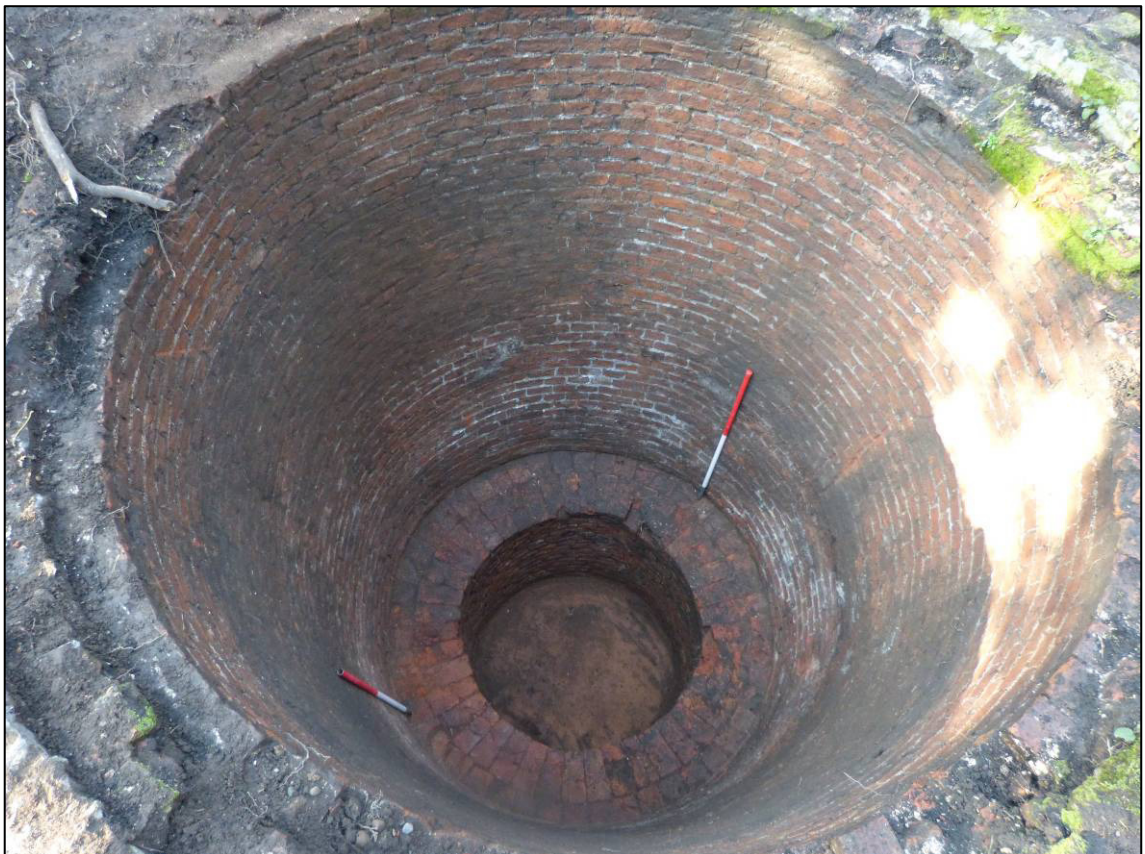
Plate 4: Fully excavated ice well, looking NE (2 x 1m scale) (photo 3/252).

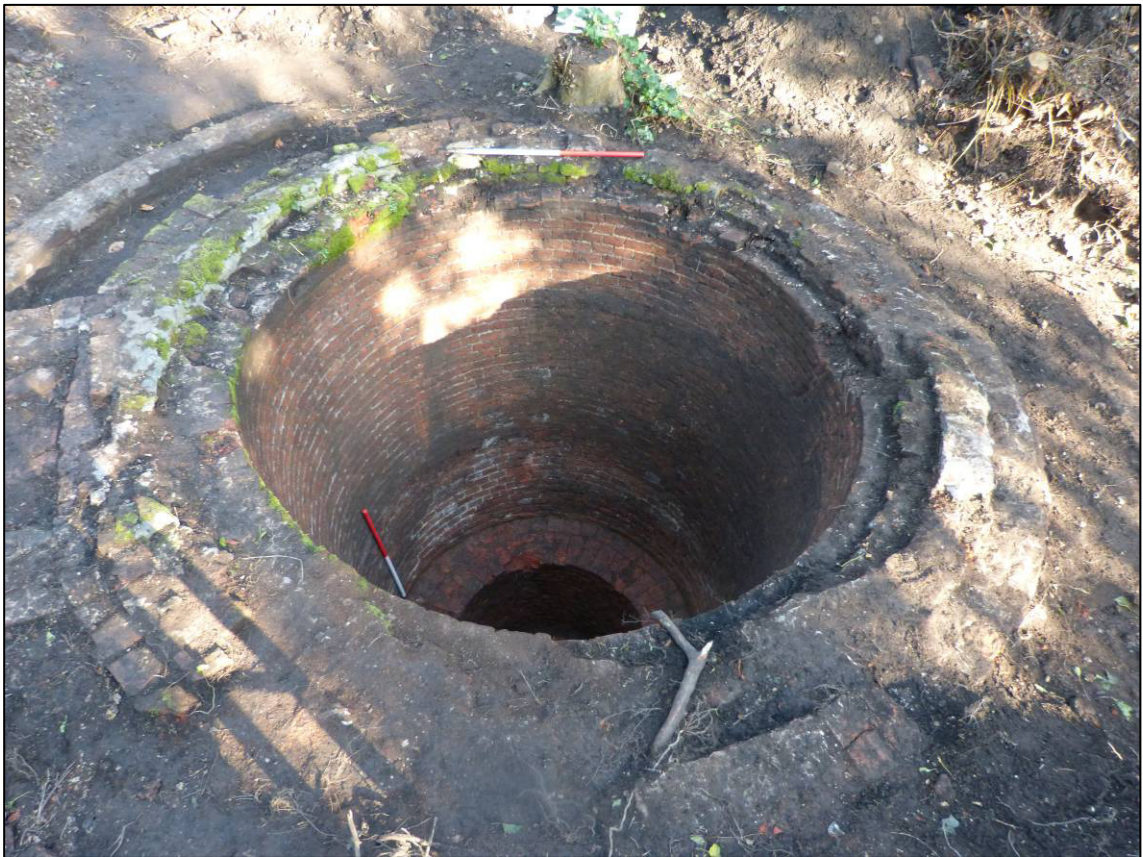
Plate 5: Fully excavated ice well, looking S (2 x 1m scale) (photo 3/253).

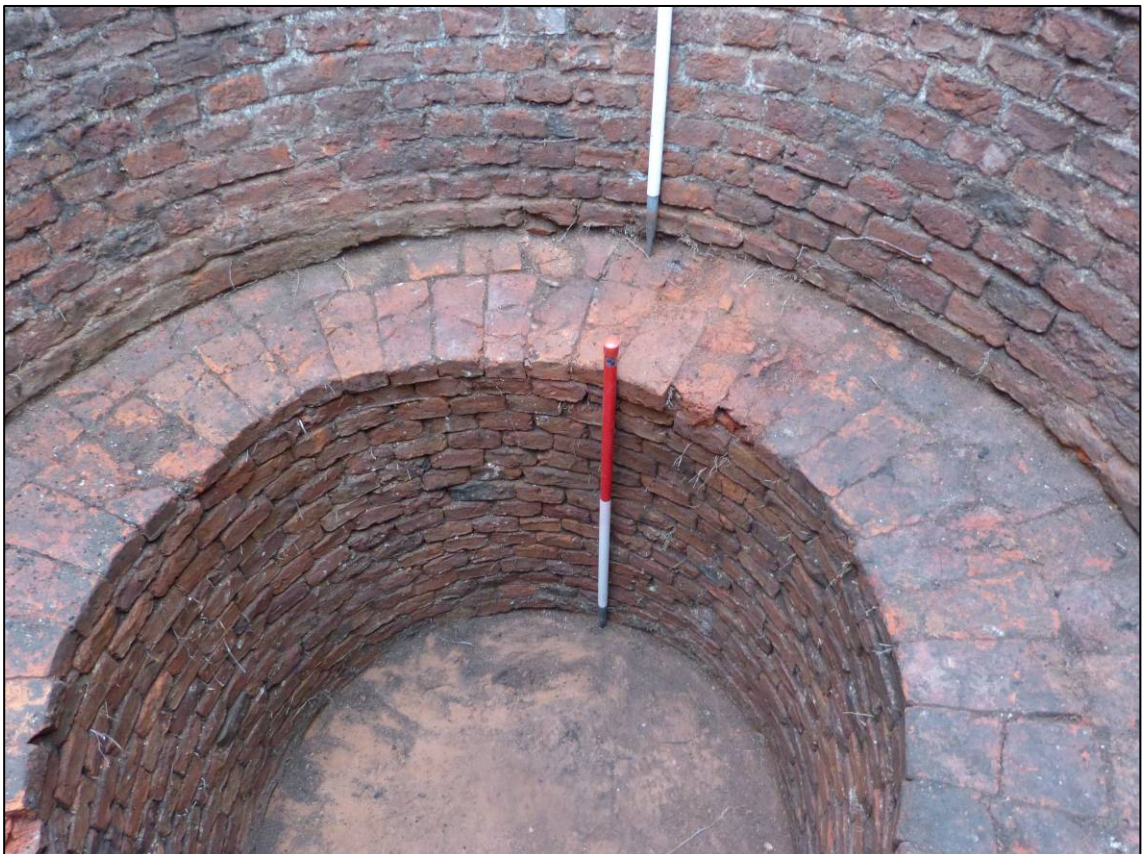
Plate 6: Fully excavated ice well showing sump, looking N (2 x 1m scale) (photo 3/268).

- 5.7 The sandy silt with frequent brick rubble (002) continued to 2.80m below the level of the top of the sides, to the point where they stepped inwards to form the ice house's sump. The sump, which was 1.00m deep, was largely filled with a similar deposit (003) to the drier sandy silt (002). In the base of the sump, the latter deposit overlay a 0.10m deep layer of very dry light-brown sandy silt (004) with frequent inclusions of dried powdery wood. Beneath the light-brown sandy silt (004), and extending beneath the brickwork at the base of the sump, there was a layer of clean, dry, orange sand (005).
